Challenge: A large OEM of telescopic material handling equipment had experienced severe quality defects on its combination fuel/hydraulic reservoir causing assembly line downtime and field warranty failures.

Solution: Utilizing the Helical Program, Helgesen helped the customer realize a cost savings of 9% while producing a defect-free assembly utilizing the following techniques:

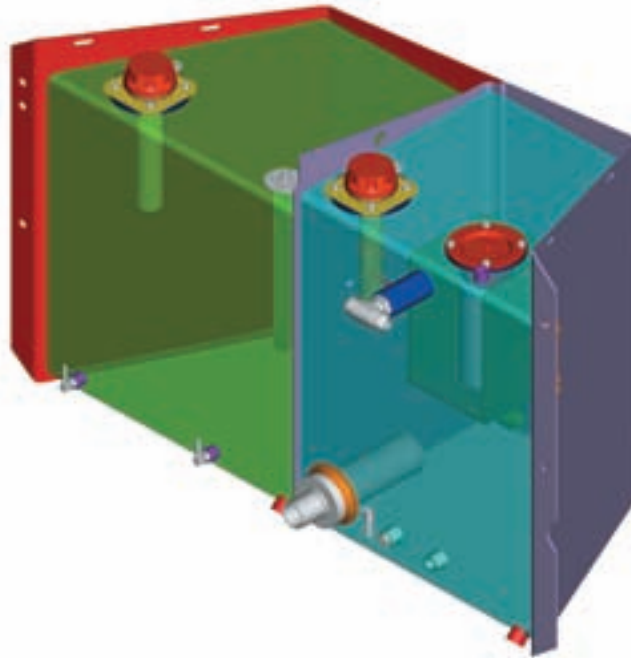
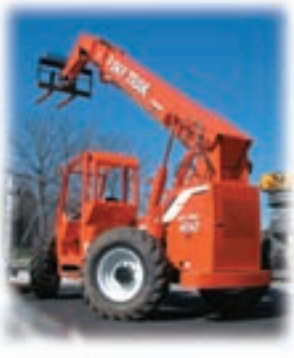
- ▶ **Reduced potential failure modes by redesigning the reservoir. Modified part fit-up, bend radii, material types and drain locations to create a defect-free assembly.**
- ▶ **50% reduction in reservoir leak point weld seams.**
- ▶ **7x increase in manufacturing throughput by applying R4 production streets.**
- ▶ **In-house paint capabilities enabled better appearance control for a highly cosmetic assembly.**
